**NEW CROTON RESERVOIR DAM
WESTCHESTER COUNTY, NEW YORK
INVENTORY NO. 46**

**PHASE I INSPECTION REPORT
NATIONAL DAM SAFETY PROGRAM**

NEW YORK DISTRICT CORPS OF ENGINEERS

AUGUST 15, 1978

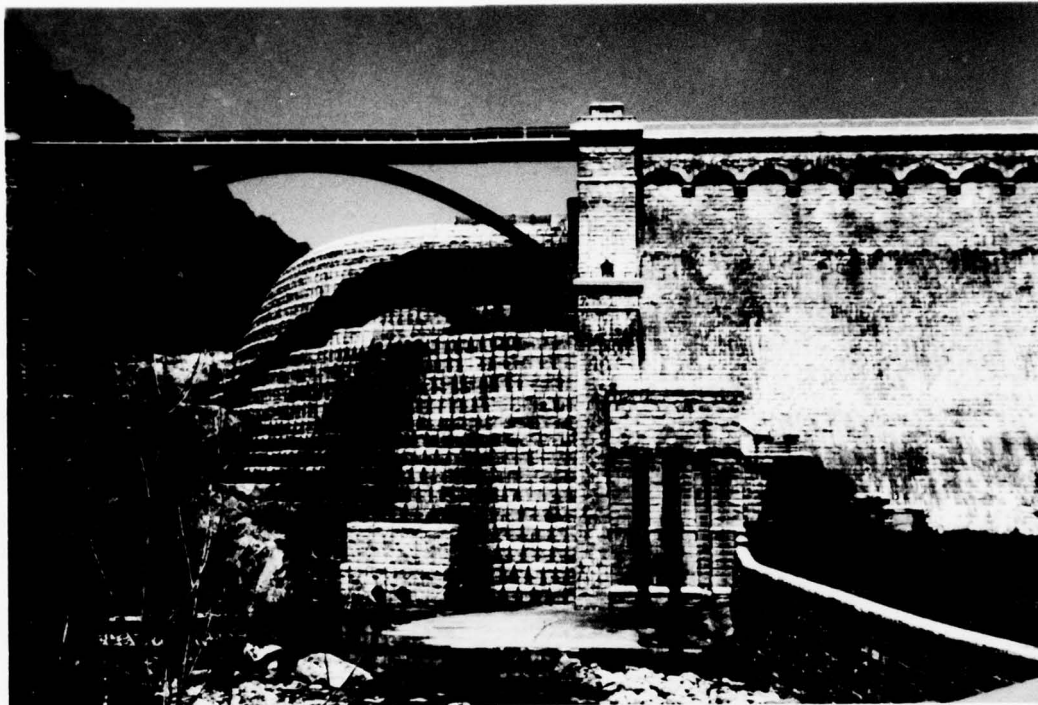
(K)* The concrete apron downstream of the spillway channel and Gate House No. 2 blow-offs suffered moderate damage (cracks, eroded portions).

The seepage through the spillway and its foundation (Observations (F) and (J)) indicate a somewhat damaged condition of the structure resulting from the 1955 flood. The seepage suggests the presence of cracks and water pressures of unknown distribution inside of the structure. At freezing temperatures, seepage water may cause frost damage.

DOWNSTREAM VIEW OF SPILLWAY BRIDGE AND OUTLET STRUCTURES. THE PICTURE SHOWS SEEPAGE ON THE DOWNSTREAM FACE OF SPILLWAY, OBSERVATION (F) AND DAMAGED CONCRETE APRON, OBSERVATION (K).

a. The spillway and tailrace channels should be cleared and their surface made smoother by removing loose rocks and filling depressions with concrete. The apron downstream of the spillway should be repaired.

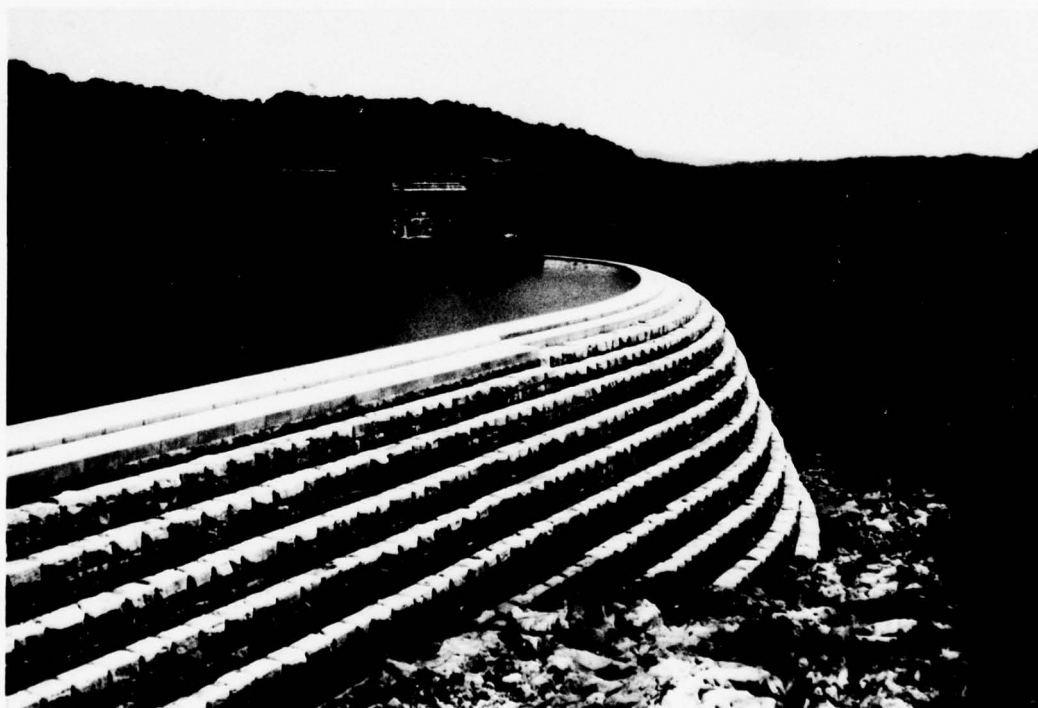
(J)* Some seepage appears to emerge at the contact of the masonry structure and its foundation along the spillway channel.

SPILLWAY AND GATE HOUSE NO. 2 (NORTH) VIEWED FROM THE SPILLWAY CHANNEL. THE WATER IN THE CHANNEL IS SEEPAGE FLOW, OBSERVATION (J).

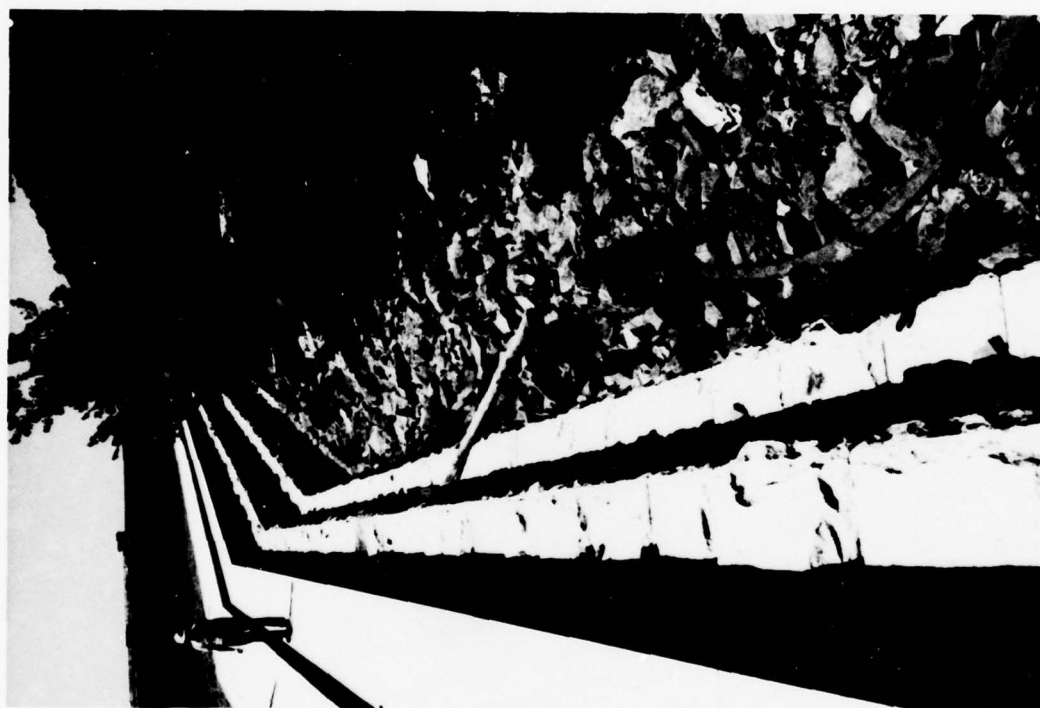
(H)* Debris, trees and shrubs were found in the upper portion of the spillway channel.

UPSTREAM END OF SPILLWAY CHANNEL. SOME DEBRIS, TREES
AND SHRUBS ARE PRESENT, OBSERVATION (H).

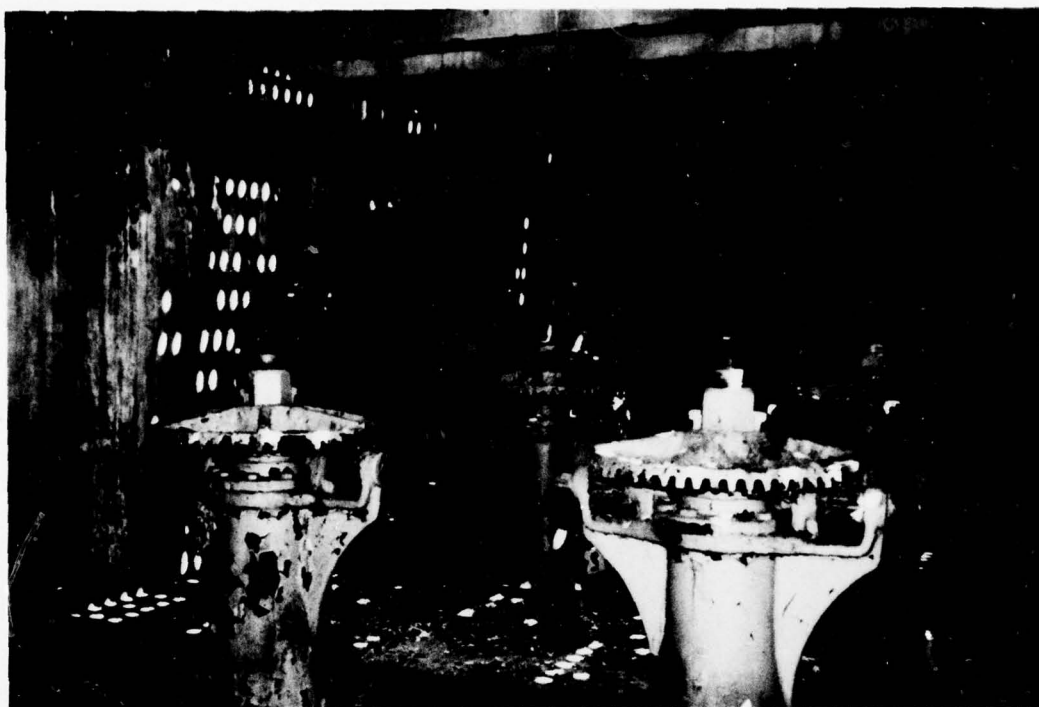
(M) Gate stand surfaces have extensive paint peeling and some rusting.

(P) Some of the roof and floor grating panels were broken and missing. The floor is strewn with debris.

GATE HOUSE NO. 1 (SOUTH) SHOWING RAISED SHIELD AT ENTRANCE TO THE OLD AQUEDUCT LEADING TO THE NEW CROTON GATE HOUSE; MISSING FLOOR PANELS, AND CONDITION OF GATE OPERATING STANDS, OBSERVATIONS (M) AND (P).

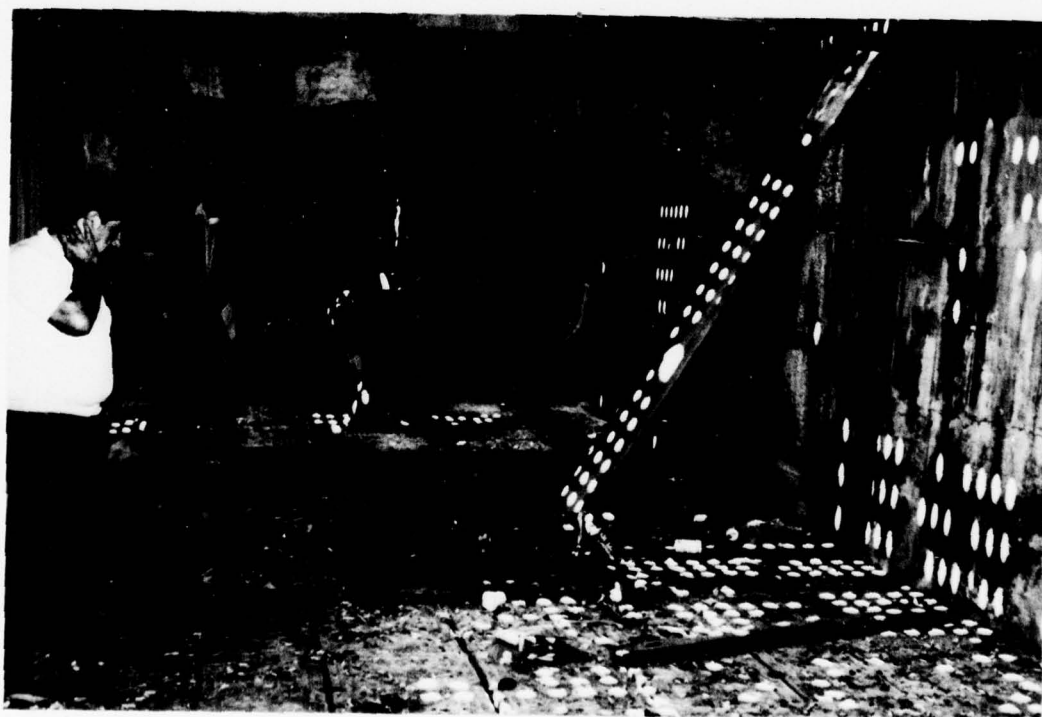
(Q)* The sluice gate of the north blow-off pipe was open and hung with the operating stand removed. The balance valve was closed and said to be operable but leaking.

GATE HOUSE NO. 2 (NORTH) SHOWING DISMANTLED OPERATING STAND OF INTAKE SLUICE GATE, AND OPERATING STAND OF BALANCE VALVE FOR NORTH BLOWOFF PIPE, OBSERVATION (Q).

b. The gates and valves of the three blow-offs in Gate House No. 2 should be repaired or replaced. These facilities are essential for lowering the reservoir. In connection with the repair of the low level outlet facilities the relocation of the left tailrace retaining wall may be considered. Reportedly, this wall is subject to damage when the south blow-off is operated.
